Approach

NAVAER 00 75-510

THE NAVAL AVIATION SAFETY REVIEW

Vol 2 # 6
PUBLIC LIBRARY
NOV 20 1956
DETROIT
MB

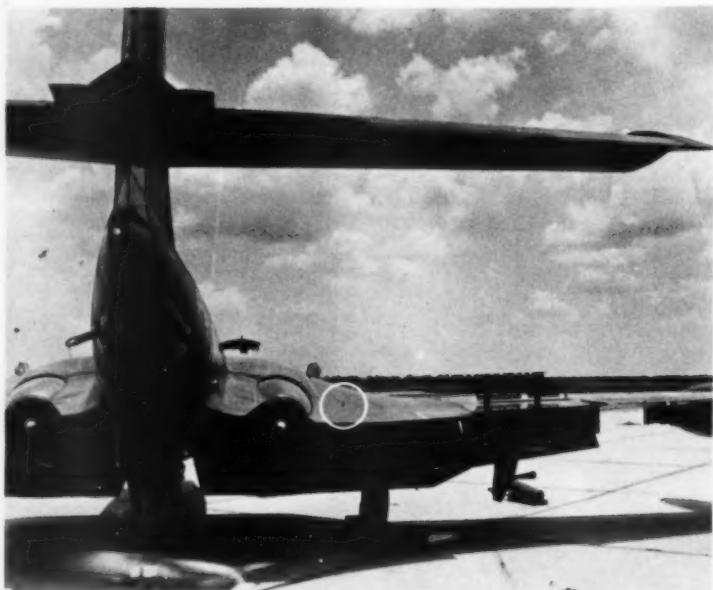
Bullet hole in tow plane (circle) resulted from improper firing angle.

After landing, the plane captain of the tow plane informed the pilot that the starboard stub wing had been hit. One round had entered it at a flat angle. Damage was limited to secondary structural members and the wing skin.

Though the firing pilot had a record of low angle-off runs, and on the run in question, was observed to be very flat, at a high angle of bank and well aft, evidence indicated that the round which struck the tow aircraft was in fact a ricochet off the tow bar.

The projectile was found laying on the lower skin of the stub wing. The nature of the entry point and extent of internal damage indicated a reduced velocity. The tow bar was holed and paint the same color as used by the firing pi-

free of paint. Firing runs were all starboard side but the bullet entered the wing slightly port to starboard.

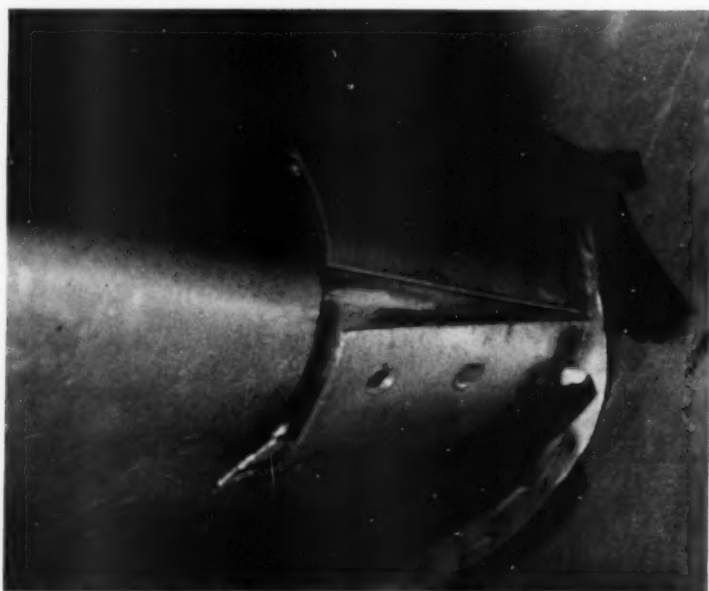
In addition to leading edge damage, clear air turbulence popped rivets along the main spar of the wing.

lots were leaving the aircraft the plane captain drew their attention to structural damage of the right wing. In addition to popped rivets and split skin along the main spar cap, the wing was found to be twisted and forced upward in excess of one inch.

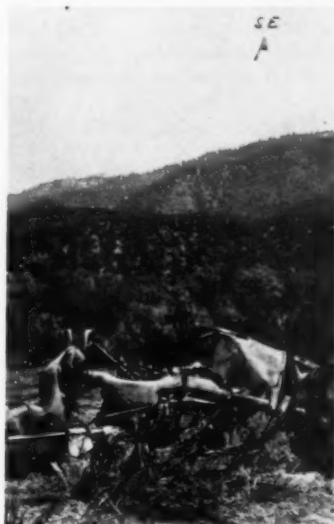
On the downwind leg of his landing approach the pilot was low and slow. A gust of wind from behind dropped the HUP even though full power was applied.

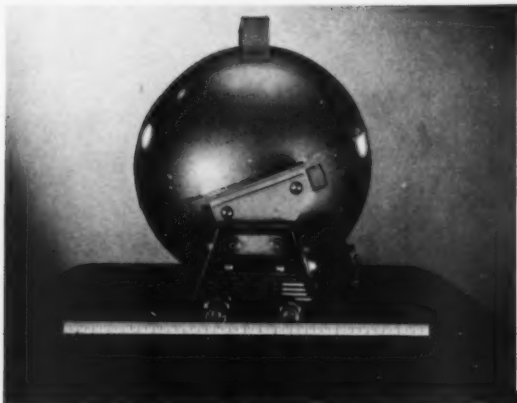
Five-liter LOX container of the type installed in FJ-3, -4 aircraft.

20 liters per minute as demanded by the pilot. The FJ-4's supply of LOX is stored in a 5-liter (about 5.3 U.S. qts.) vacuum insulated container. A liquid oxygen conversion system maintains the delivery pressure and volume. The amount of LOX to be evaporated is controlled by means of a pressure operated control valve. After evaporation, the oxygen passes through a heat exchanger (warm-up coil) to raise its temperature, and then is delivered to the diluter-demand regulator for the pilot's consumption. A system relief valve vents excessive pressures overboard that may occur due to the boil-off of LOX. An electrical capacitance type indicator provides the pilot with an accurate means of determining the amount of LOX remaining at any time.

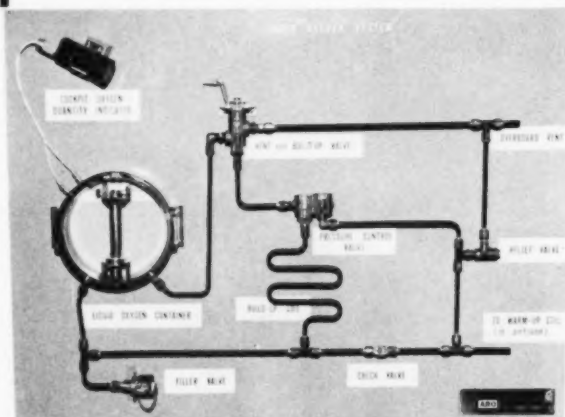
Cutaway schematic of the Aero LOX system.

The LOX system in the FJ-4, for example, is a low-pressure system which provides gaseous oxygen to the diluter-demand regulator at a pressure of 70 psi and delivery rates up to

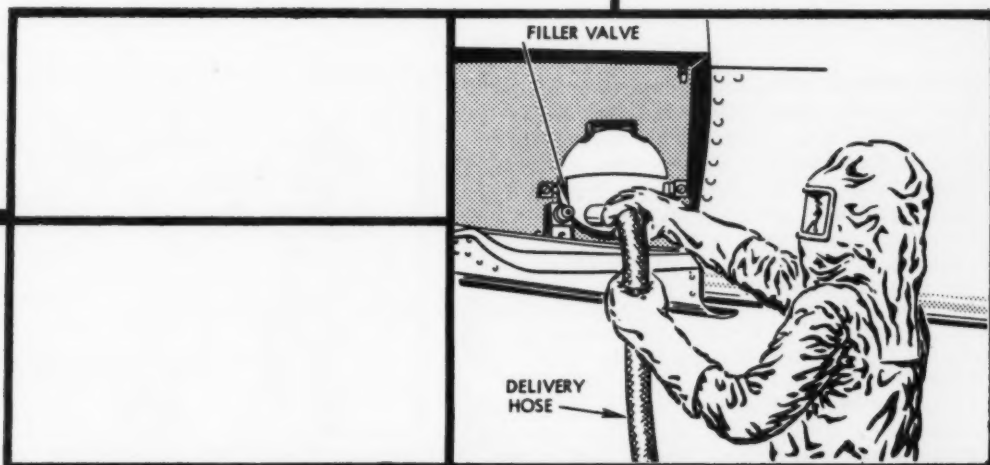
Protective clothing must be worn by those who handle LOX.

The extreme cold of LOX will instantly produce burns if held in contact with the skin. Protective clothing and equipment consisting of a suitable face mask, shield, apron and

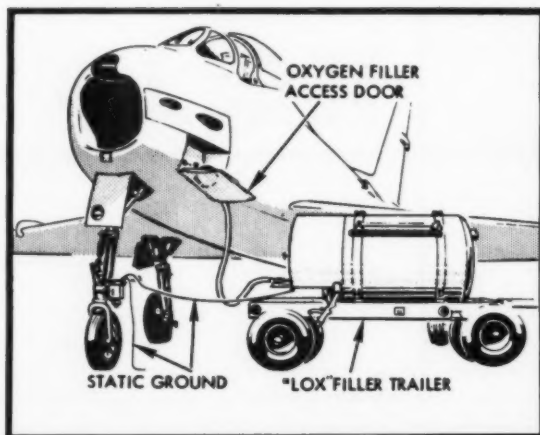
A static ground is connected from LOX trailer to aircraft and aircraft to deck.

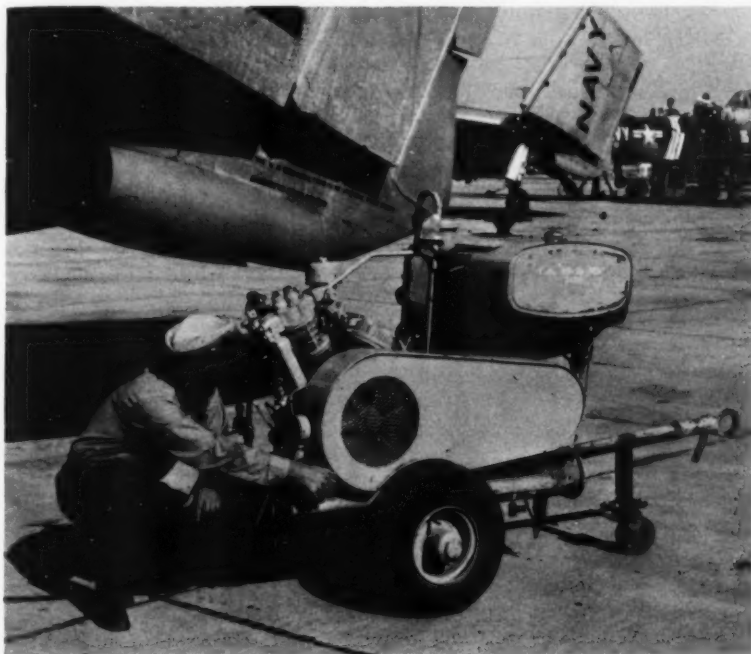
It takes only a few minutes to disconnect the single hose from the high side and put it on the low pressure side.

Bowsers frequently defective on the low pressure side and consequently tempt men to use the high pressure side.

in this accident is continuing and it is possible that a defective wheel was at the root and not excessive inflation. Regardless of the outcome, however, the fact still remains that modern high-pressure tires inflated with several hundred pounds of air are potentially several sticks of dynamite waiting to go off in the face of an unsuspecting person.

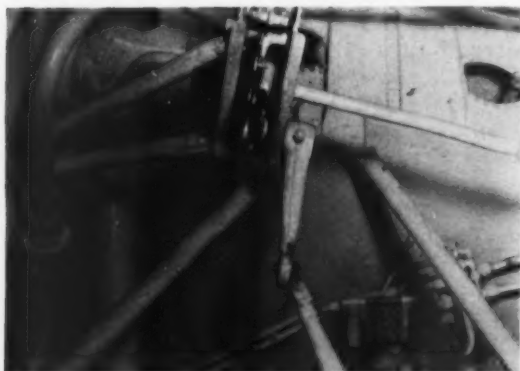
A bent J-hook caused by improper rigging of the main gear up-lock, led to landing the S2F wheels-up.

RIGGING S2F WHEELWELL DOORS—Following the third touch-and-go landing, a waveoff was executed and the starboard main landing gear doors failed to close after the gear was retracted. The gear was recycled and the doors closed. Following another touch-and-go landing, the starboard wheelwell doors again failed to close. The gear was recycled but the starboard main landing gear would not extend. All attempts to extend the gear were unsuccessful and an intentional wheels-up landing was made on a foamed runway.

A ground check of the landing gear on this aircraft also revealed a malfunctioning landing gear timer check valve, P/N 159480-3, causing the wheelwell doors to start closing before the landing gear was up which intensified the linkage adjustment error and caused the up-lock hook to be bent far enough outboard to wedge between the roller and supporting bracket and prevent the extension of the starboard main landing gear.

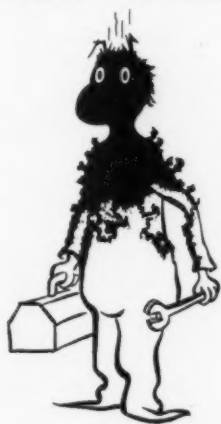
POOF!—As a mechanic looked into the tailpipe of a jet to see if the fire was completely out an explosion occurred. His face, ears, neck,

The explosion was caused by a partly-opened throttle which allowed fuel to accumulate.
